### The "Lazy S" feature in Friction Stir Welding of AA2099 Aluminum-Lithium alloy

**THE “LAZY S” FEATURE IN FRICTION STIR WELDING OF  
AA2099 ALUMINUM -LITHIUM ALLOY**

Holli K. Klages

December 2007

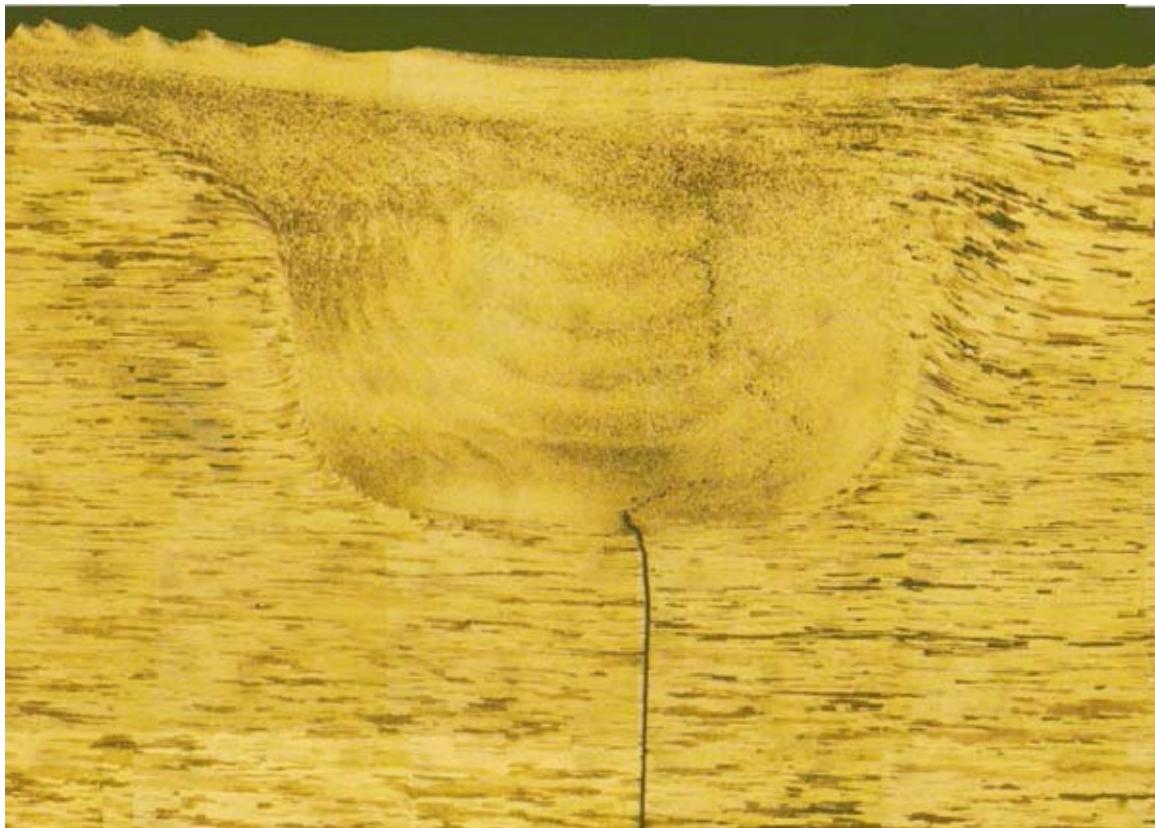
The weld joined an anodized Al-Li sample to an unanodized Al-Li sample with a standard tool along the centerline. The appearance of the “Lazy S” is evident in both the transverse and plan view. Figure 4 shows a transverse view where the “Lazy S” first appears near the surface of the advancing side. The line gently slopes towards the retreating side where it drops down into the bottom third of the stir nugget before

hooking one last time back towards the bottom center of the stir nugget. The plan view shows a section half way down into the stir nugget. Figure 5, shows the plan view in which a jagged saw-tooth pattern is left behind from the weld.

**Figure 4. Transverse View of Anodized to Unanodized Al-Li alloy, centerline weld with Standard tool (sample 1076)**

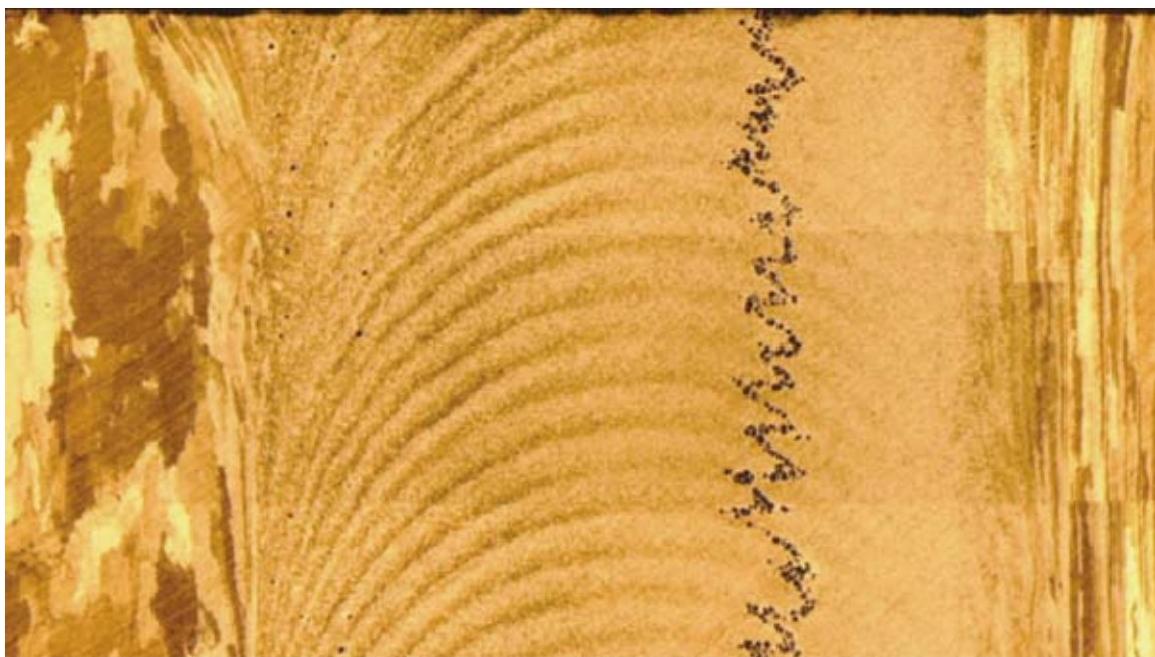
**Figure 5. Plan-view of Anodized to Unanodized Al-Li alloy, centerline weld with Standard tool (sample 1076)**

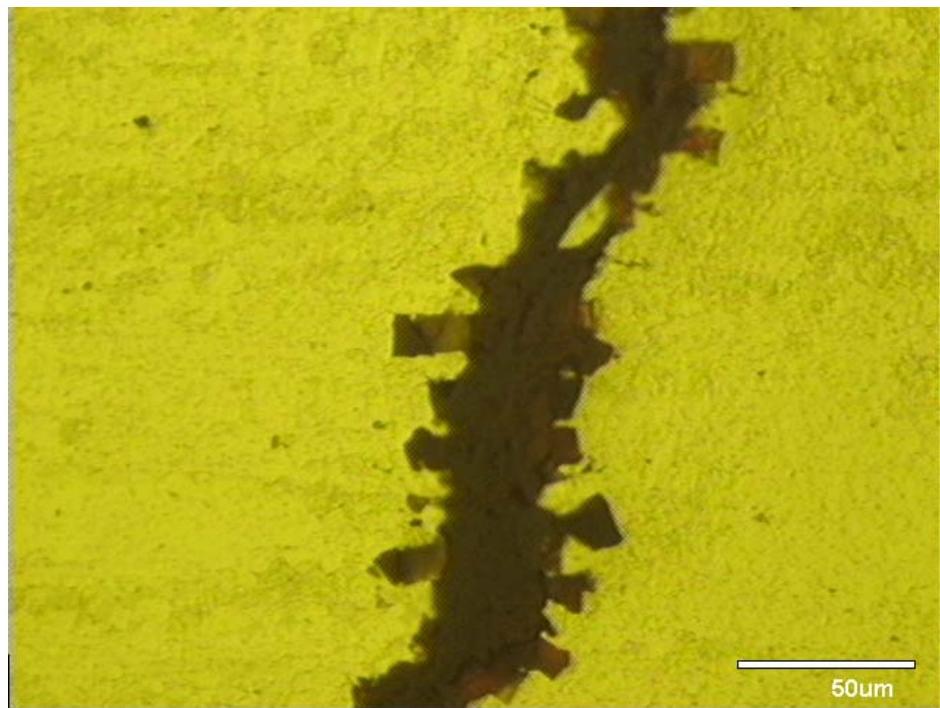
Figure 6 narrows in on the “Lazy S.” Due to the joining of an anodized metal to an unanodized metal, it appears the “Lazy S” is composed of oxide remnants.

**Figure 6. “Lazy S” Located at the bottom of the stir nugget (sample 1076)**

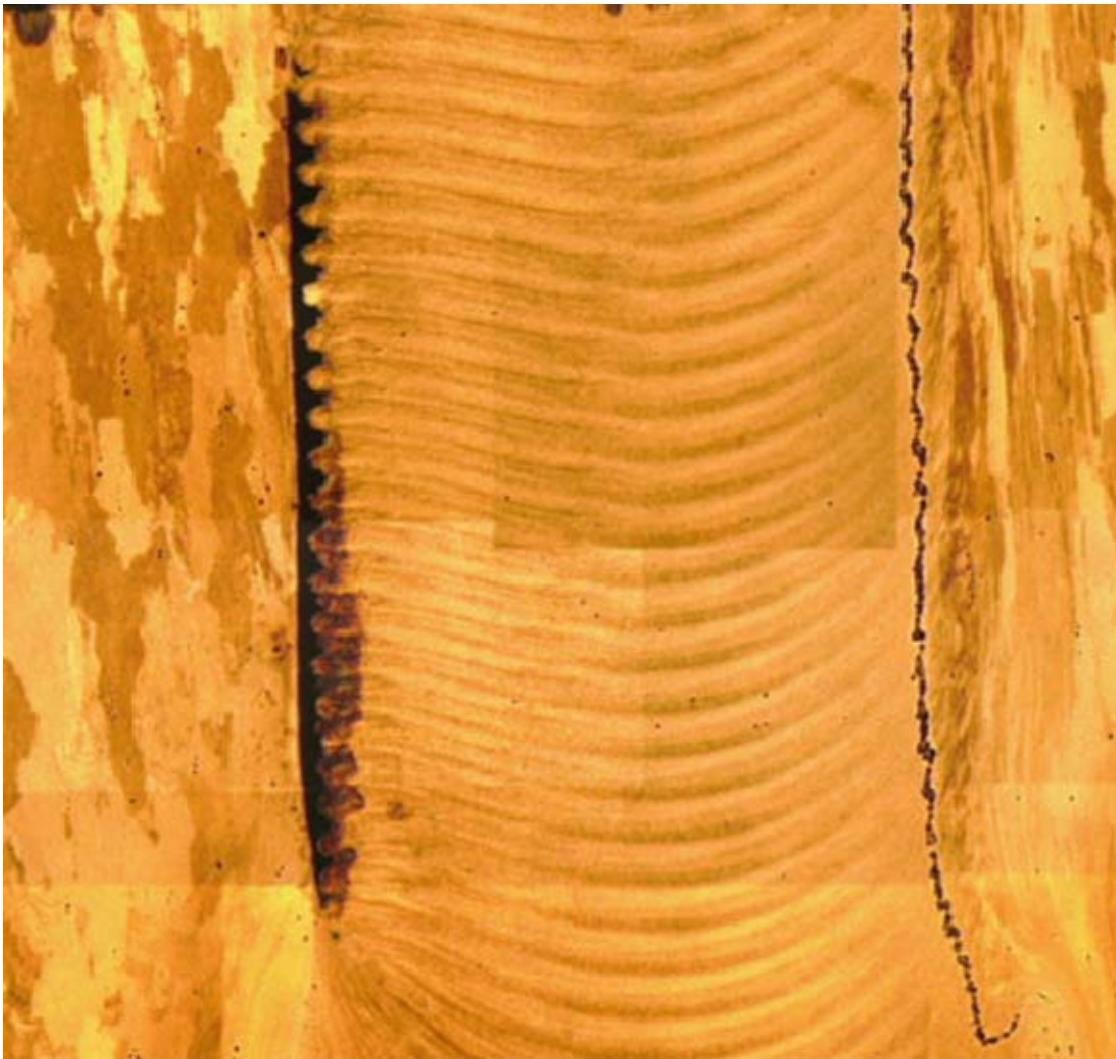
two samples discussed fit into the basin-shaped category. The second category is elliptical as seen in sample 1107. Just as in the previous two samples, the “Lazy S” appears from the advancing side under the tool shoulder and extends to the retreating side before dropping straight down. The “Lazy S” favored the retreating side and is created by the remnants of the faying surface. Figure 8 and 9 show the transverse and plan view respectively. Unique to this sample is a distinct tunnel defect on the advancing side of the stir nugget. This did not appear in any of the other samples. Prior to FSW, the samples were examined and determined to be defect free. The major difference with the creation of this sample was the use of a Tri-flat tool versus a standard tool. The plan view represents a cut half way down into the stir nugget region and shows both the saw-tooth pattern from the “Lazy S” and the large defect.

**Figure 9. Plan View of Anodized to Unanodized Al-Li alloy, weld location on the retreating side with a Tri-Flat tool. (sample 1107)**

1. Examine more samples using the Tri-flat tool to determine if the large defect across from the “Lazy S” in the stir zone is related to the tool.
2. Conduct more hardness tests on larger samples in order to get more than three passes across the stir zone.
3. Compare hardness data with samples welded under varying RPM/IPM ranges.

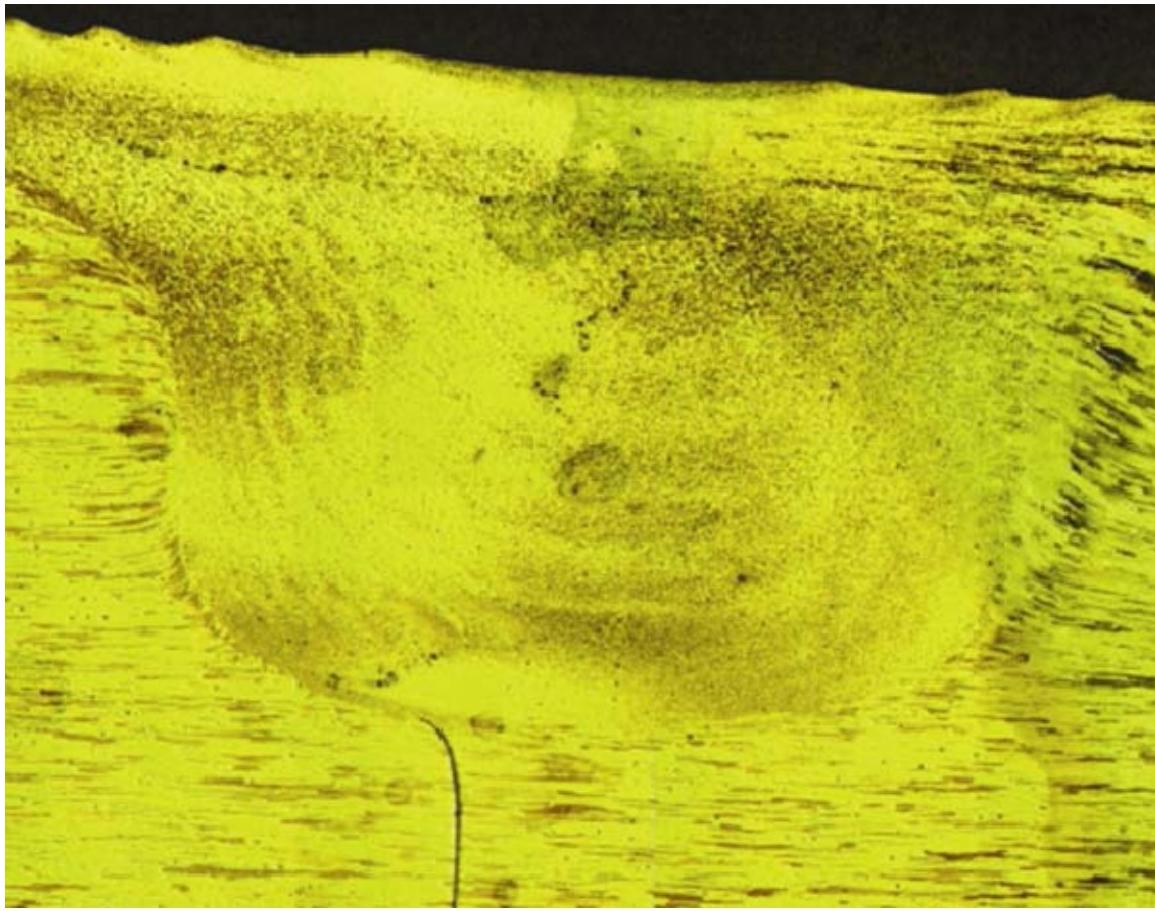
The weld joined an anodized Al-Li sample to an unanodized Al-Li sample with a standard tool favoring the advancing side for the path of the weld. The path of the “Lazy S” starts from the advancing side, traverses to the middle of the stir nugget, drops down and curves towards back towards the advancing side before exiting the stir nugget on the advancing side. Again the “Lazy S” is the remnants of the oxide leaving behind a trace history and is shown in Figure 10.

**Figure 10. Anodized to unanodized, weld location on the advancing side with a standard tool. (sample 1106)**

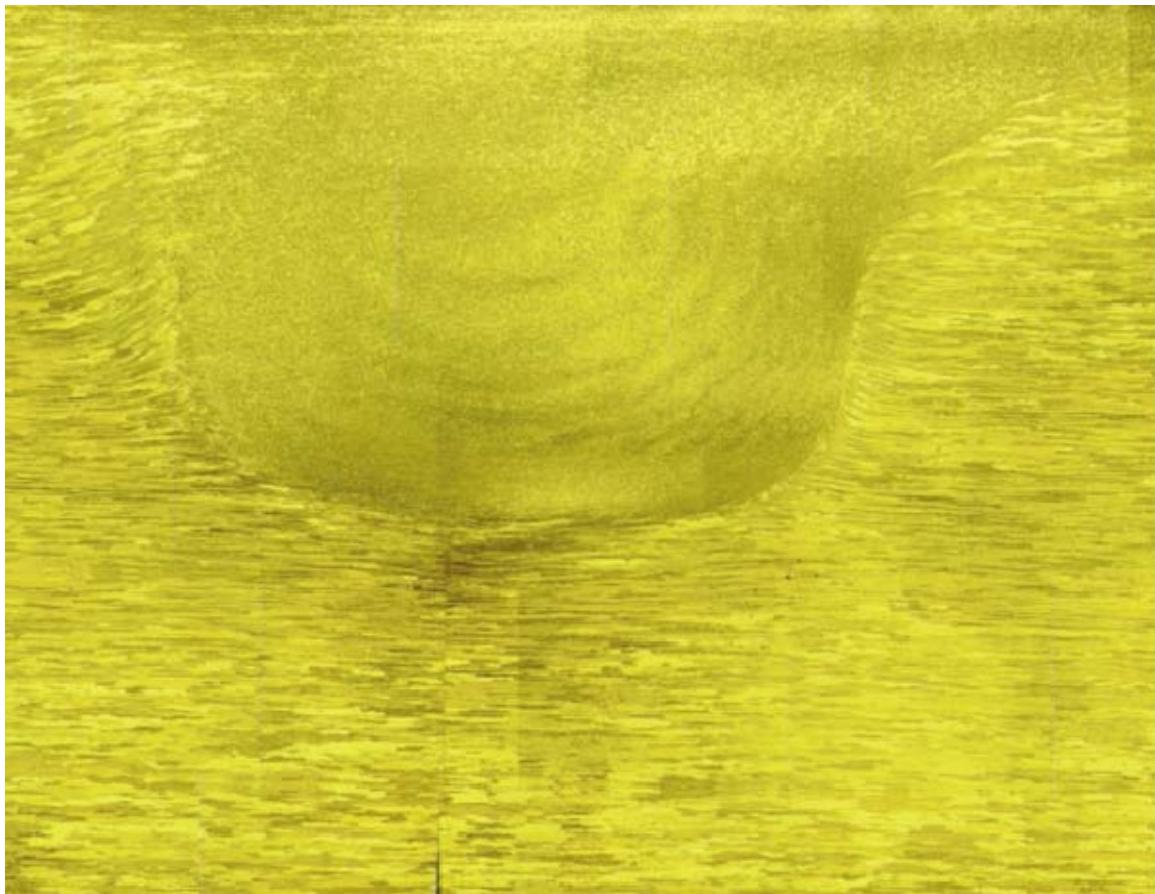
The following three samples do not show the presence of the “Lazy S” defect. Sample 1108 represents the product of two unanodized Al-Li samples with a standard tool FSW along the centerline. The stir zone is elliptical in shape and is shown in Figure 11. Samples 1109 and 1110 were friction stir welded using a standard tool displaced toward the retreating and advancing side, respectively, and are shown in Figures 12 and 13. Without the anodized metal, the ability to trace the faying surface is difficult or impossible.

**Figure 11. Transverse View of unanodized to unanodized, centerline weld location with a standard tool. (sample 1108)**

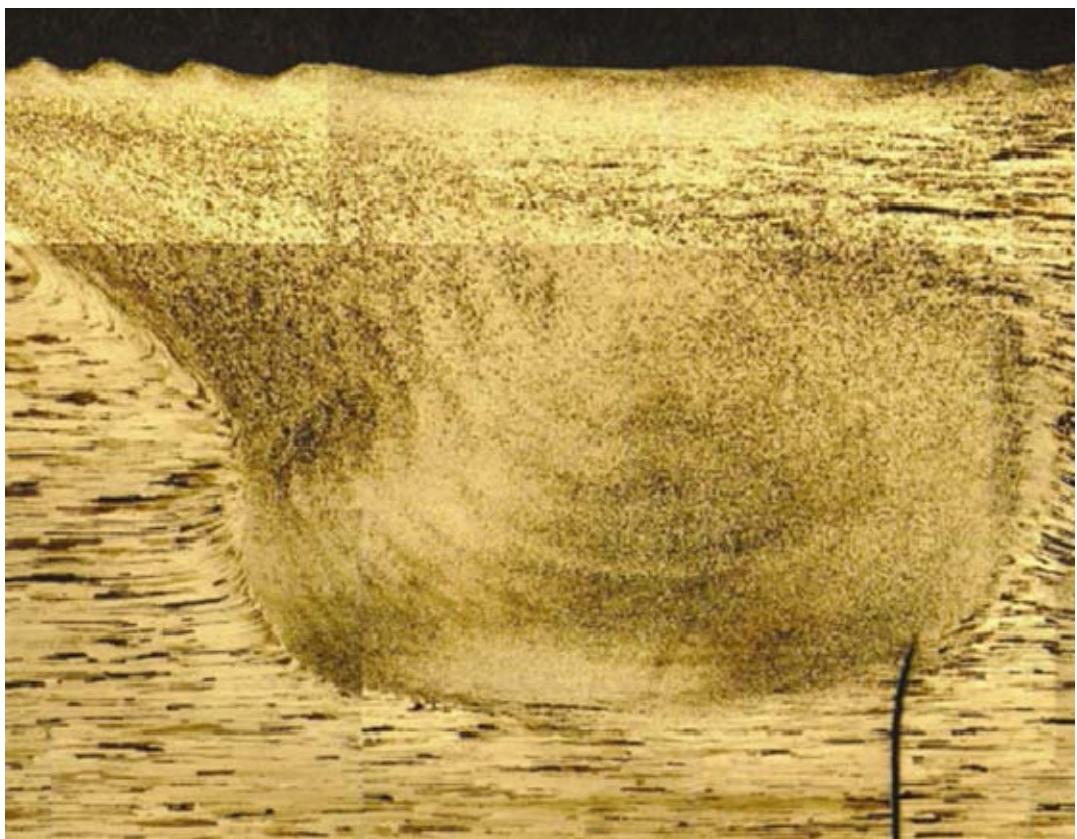
**Figure 12.** Transverse View of unanodized to unanodized, weld location on the retreating side with a standard tool. (sample 1109)

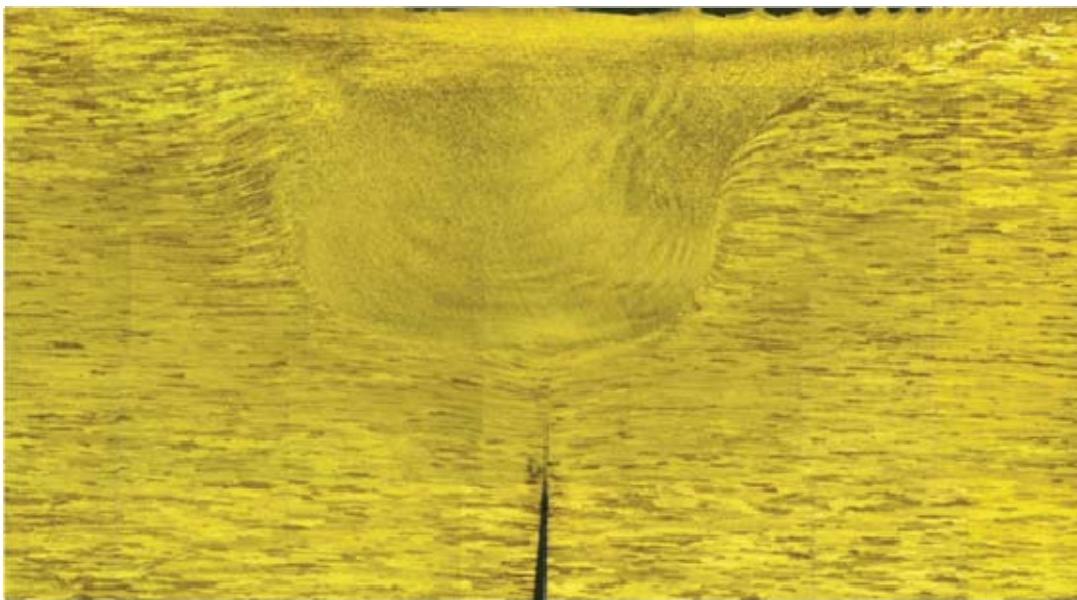
**Figure 13.** Transverse View of Unanodized to unanodized, weld location on the advancing side with a standard tool. (sample 1110)

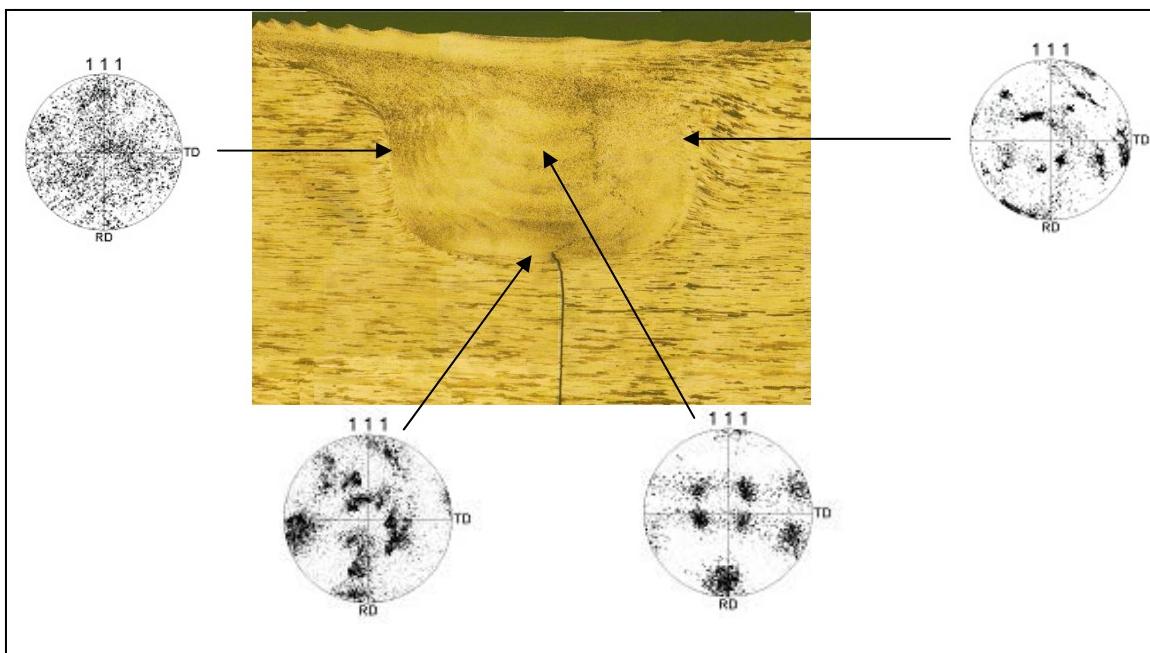
The following images show the transverse plane where varying degrees of shear texture development can be discerned. Figure 14 shows the local lattice orientations in the form of 111 pole figures. The 111 pole figure just inside the border on the left is indicative of a random texture due to recrystallization. The two pole figures from within the stir nugget nearby the nugget centerline may be indexed as A-fiber shear texture orientations ( $\{111\}<uvw>$ , where  $\{111\}$  is the lattice plane parallel to the local shear plane and  $<uvw>$  is the crystal direction parallel to the local shear direction). It is apparent that the local shear plane orientation varies from location to location throughout the weld nugget. In the center of the nugget, the OIM data suggest that the local shear plane is aligned with the plane of the plate.

**Figure 14. Kikuchi Diffraction Patterns of the Transverse View of Anodized to Unanodized Al-Li alloy, centerline weld with Standard tool (sample 1076)**

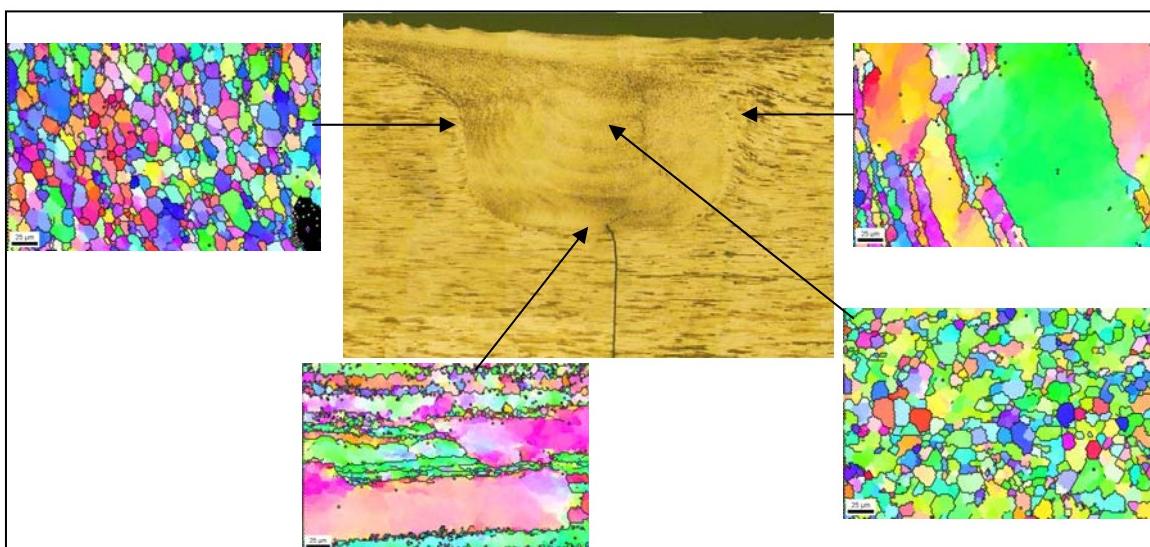
Fine, equiaxed grains are seen in Figure 15 on the advancing side and in the central regions of the nugget where grains 2 - 5 $\mu\text{m}$  in size may be discerned. Partial recrystallization is evident in regions nearby the nugget/TMAZ interface.

**Figure 15. Grain Size of the Transverse View of Anodized to Unanodized Al-Li alloy, centerline weld with Standard tool (sample 1076)**

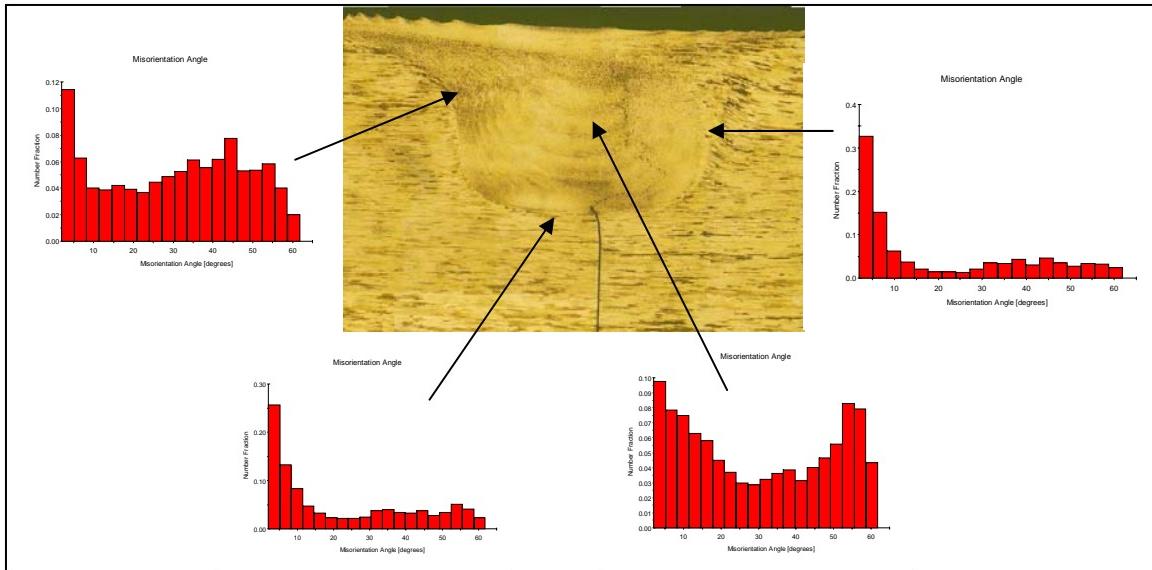
Figure 16 shows corresponding misorientation angle distributions in sample 1076. Within the stir nugget, recrystallization is reflected in large populations of high-angle boundaries. Other locations just outside the stir nugget exhibit a preponderance of low angle boundaries.

**Figure 16. Misorientation Angle of the Transverse View of Anodized to Unanodized Al-Li alloy, centerline weld with Standard tool (sample 1076)**

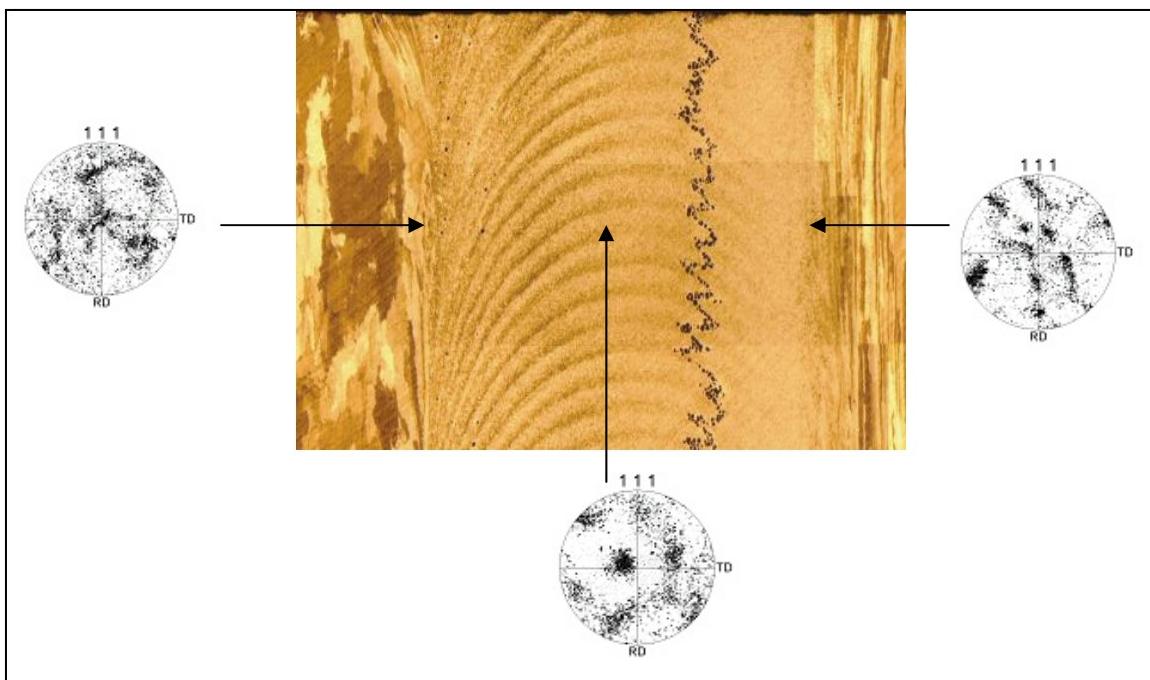
The following three pictures in Figures 17, 18 and 19 again support the varying degree of shear texture deformation. The randomness of grain size and structure throughout the stir nugget is the same and supports the presence of a shear texture. The misorientation angles also match the transverse view of low misorientation angles outside of the stir zone and high misorientaion angles within the stir zone.

**Figure 17.** Kikuchi Diffraction Patterns of the Plan View of Anodized to Unanodized Al-Li alloy, centerline weld with Standard tool (sample 1076)

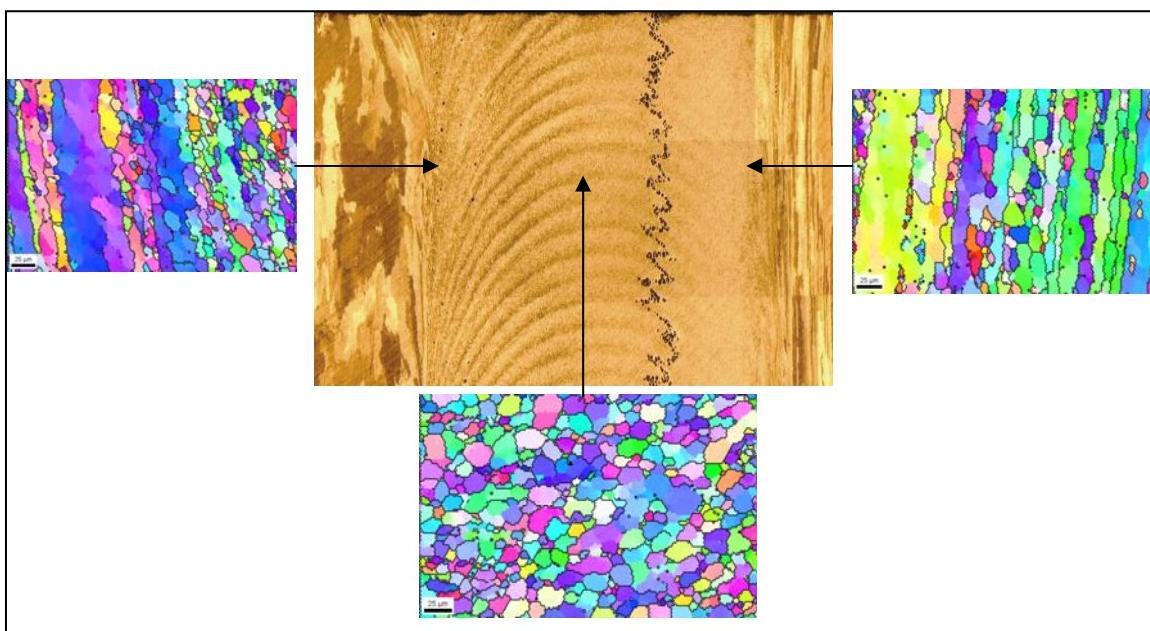
**Figure 18.** Grain Size of the Plan View of Anodized to Unanodized Al-Li alloy, centerline weld with Standard tool (sample 1076)

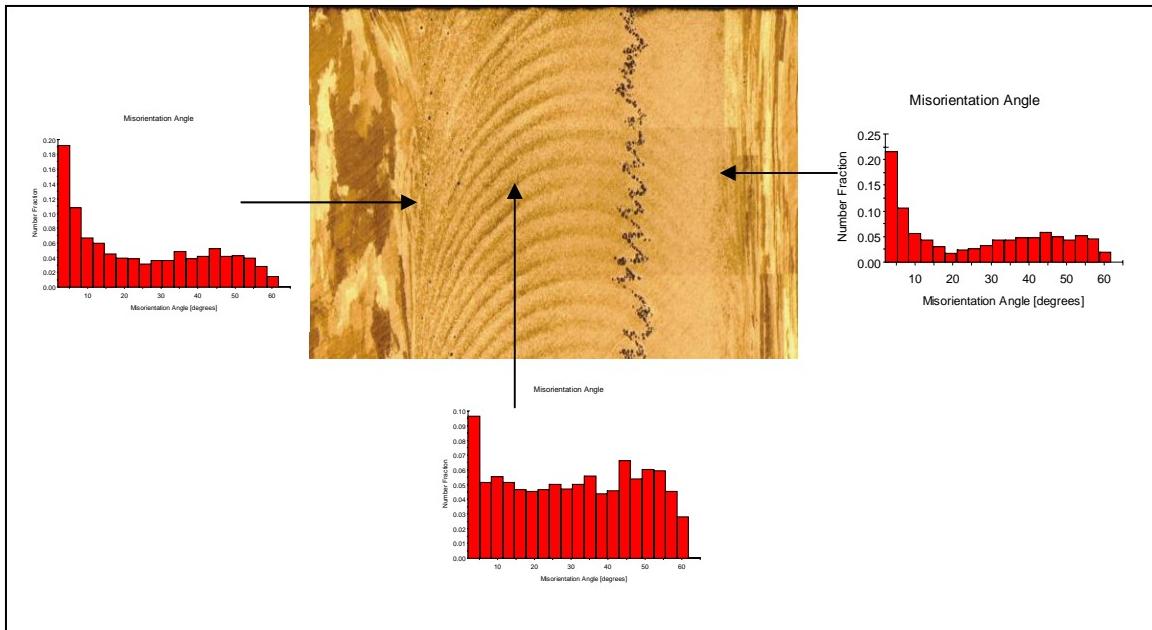
**Figure 19. Misorientation Angle of the Plan View of Anodized to Unanodized Al-Li alloy, centerline weld with Standard tool (sample 1076)**

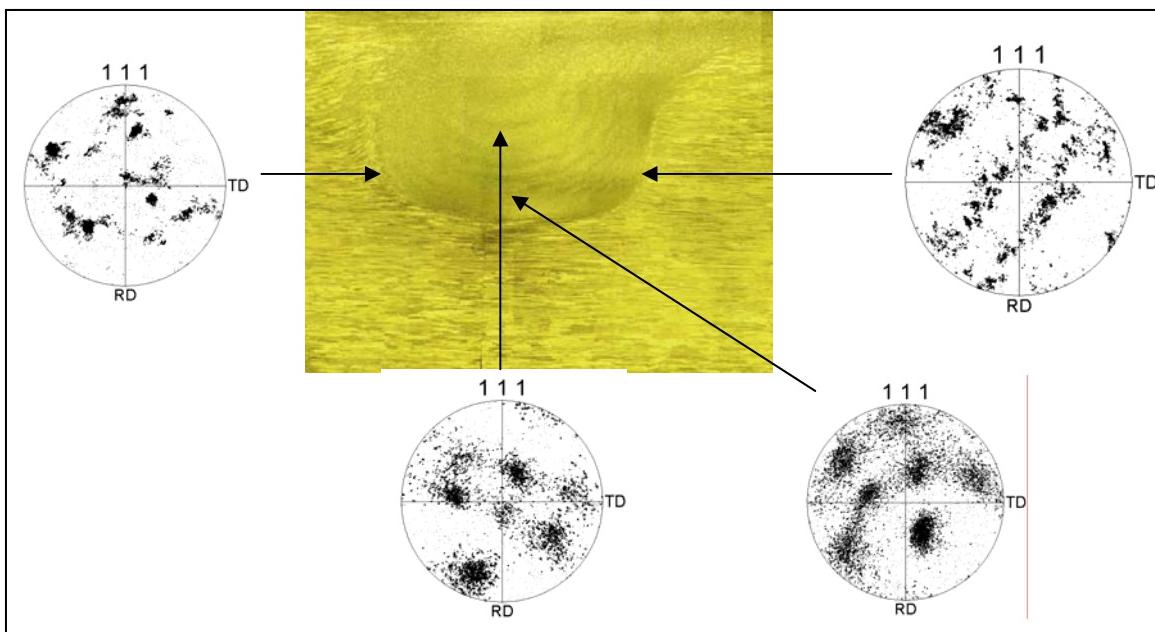
Figures 20, 21 and 22 show the local lattice orientation, grain size and misorientation angle respectively. Whereas the left border in the previous set of pictures was just inside the stir zone, the left border here is completely outside the stir zone. The pole figures of the right and left borders comprise A-fiber orientations.

**Figure 20. Kikuchi Diffraction Patterns of the Transverse View of unanodized to unanodized, centerline weld location with a standard tool. (sample 1108)**

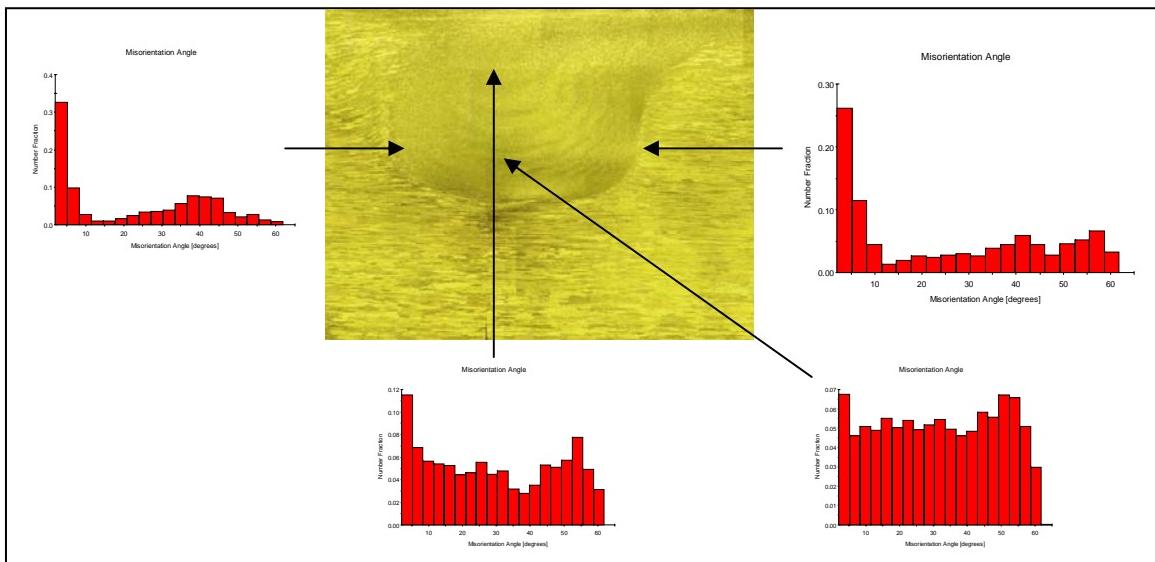
Within the nugget the size varies from 3 - 20 $\mu\text{m}$  in size. Again, the populations of high-angle boundaries are large within the nugget and lower on the border of this region.

**Figure 21. Grain Size of the Transverse View of unanodized to unanodized, centerline weld location with a standard tool. (sample 1108)**

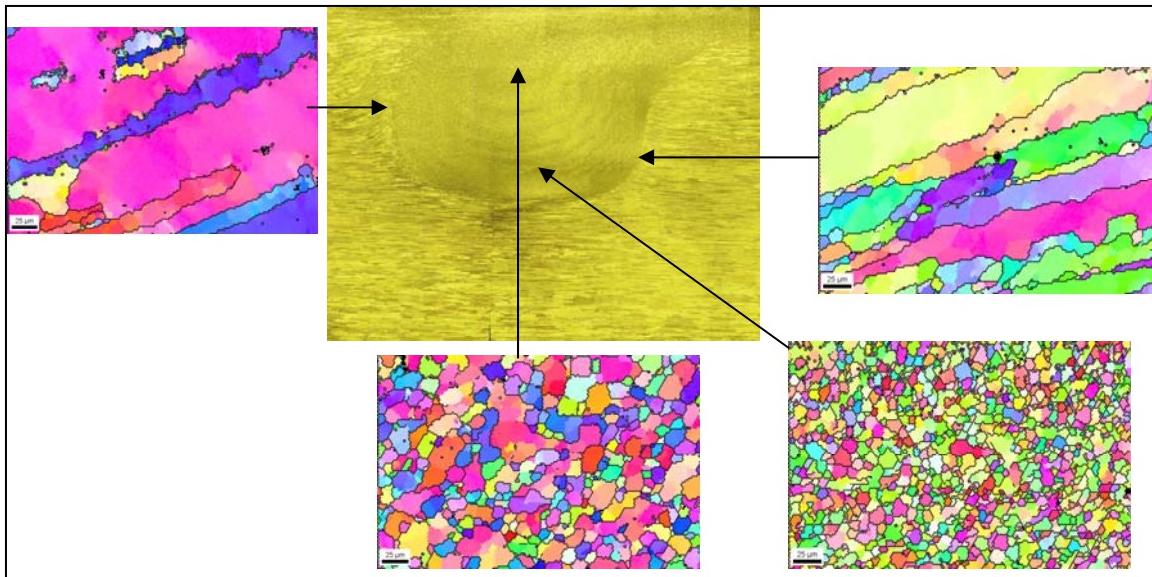
**Figure 22. Misorientation Angle of the Transverse View of unanodized to unanodized, centerline weld location with a standard tool. (sample 1108)**

A comparison of the center of the stir nugget in sample 1108 to the nugget in sample 1076 shows that the nugget in sample 1108 is more uniform. Additional analyses (not shown here) in sample 1108 indicated that this sample has a narrower band of grain size and misorientation distributions than was the case for sample 1076. Additional images are located in Appendix B.

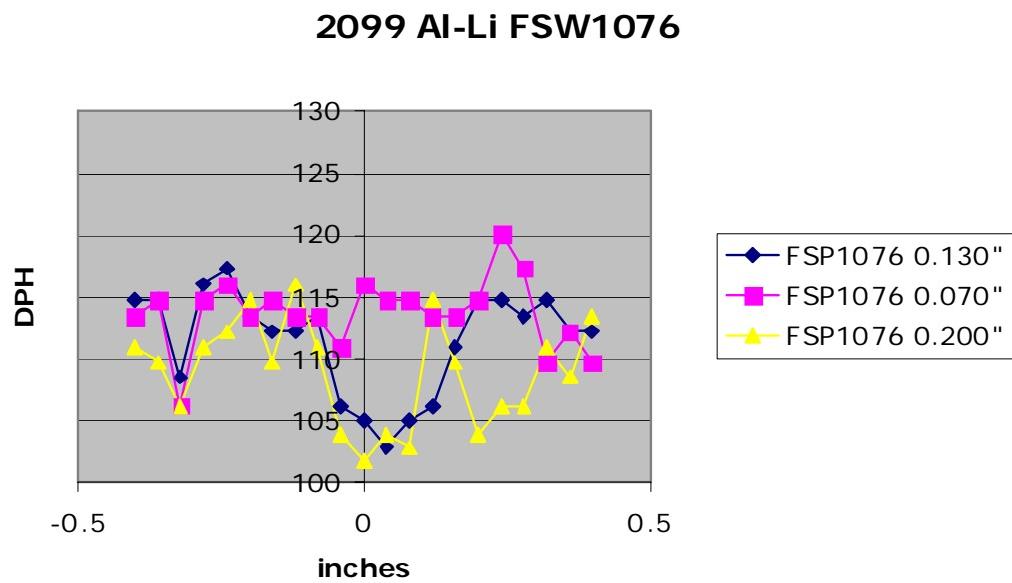
For the first pass at 0.070 inches from the surface, the results varied between 106 and 120 DPH. In the stir zone, the DPH remains quite flat and varied between 111 and 116 DPH. At the center the DPH is the highest at 116 DPH. The following passes at 0.13 inches and 0.20 inches below the surface have lower DPH values within the stir zone. For the pass made at 0.13 inches, the DPH outside the stir zone ranges from 109-117 DPH with the majority of the data points between 112 and 115 DPH. In the stir zone, the data points dropped to values ranging from 103-113. From the depth of 0.20 inches, the DPH data points are close to the previous two passes on the advancing side prior to the stir nugget. On the retreating side, the DPH data increased just beyond the stir nugget before dropping well below the values of the previous two passes. At 0.32 inches from the center on the advancing side, all three passes indicate a dip in DPH. Figure 23 shows the DPH values for all three passes.

**Figure 23. Sample 1076 (2099 Al-Li FSW)**

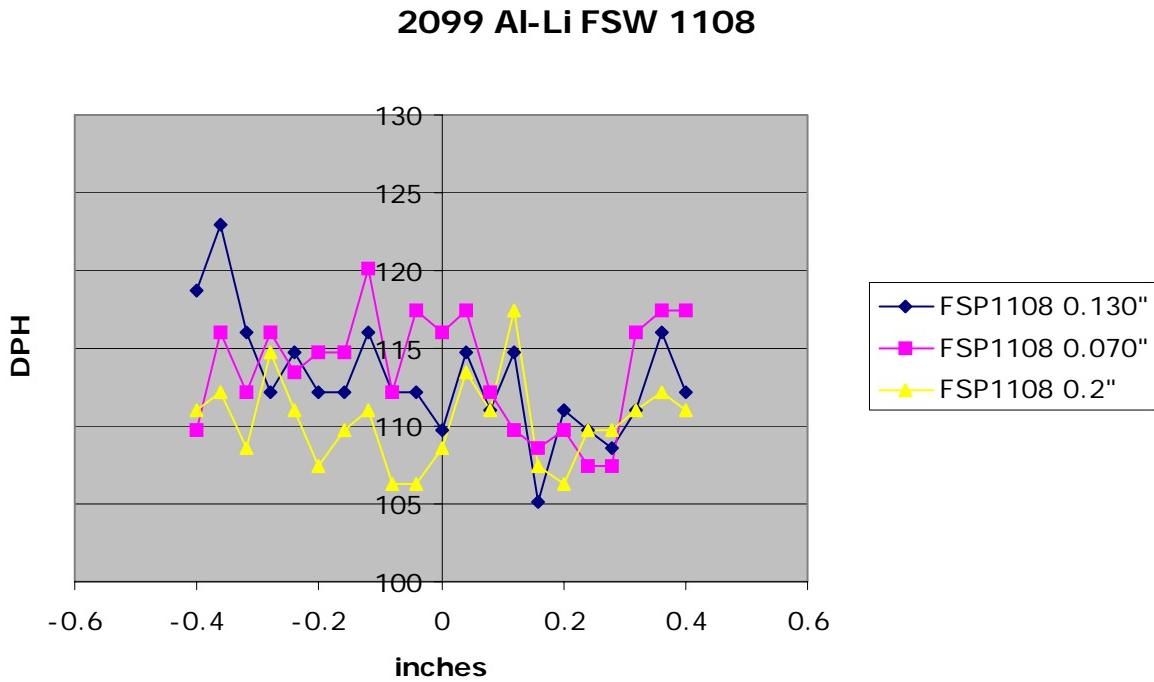
The friction stirred weld between two unanodized pieces does not have obvious dips in DPH values inside the stir zone. The pass made at 0.07 inches below the surface has DPH results between 107 and 117 DPH, the stir zone being one of the peaks vice a valley. The pass at 0.130 inches below the surface decreases from the advancing side to the retreating side with a slight increase beyond the stir nugget on the retreating side. The values range from 105 to 123 DPH with stir zone values of 105 to 115 DPH. The last pass at 0.20 inches below the surface ranges from 106 to 117 DPH with stir zone values consistent with the rest of the data points. As the depth decreased for each pass, the trend appears to be decreasing DPH values. The results are graphed in Figure 24.

**Figure 24. Sample 1108 (2099 Al-Li FSW)**

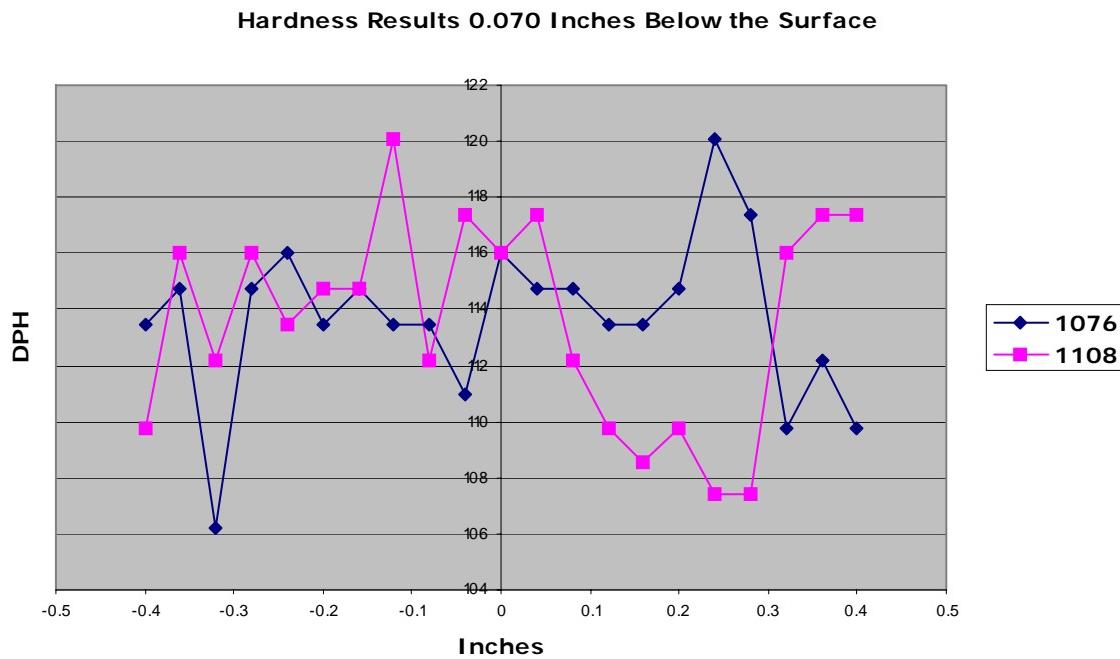
The stir zone and the advancing side just outside the stir zone are the only areas of similarity between the two samples. On the advancing side, sample 1076 has a DPH value as low as 106 DPH while 1108 spikes up to 120. On the retreating side, they do the opposite and sample 1108 drops to as low as 107 DPH at 0.28 inches while 1076 returns a value of 120 DPH. Figure 25 shows a graph comparing the two samples at 0.070 inches below the surface.

**Figure 25. Comparison between samples 1076 and 1108 0.070 inches below the surface (2099 Al-Li FSW)**

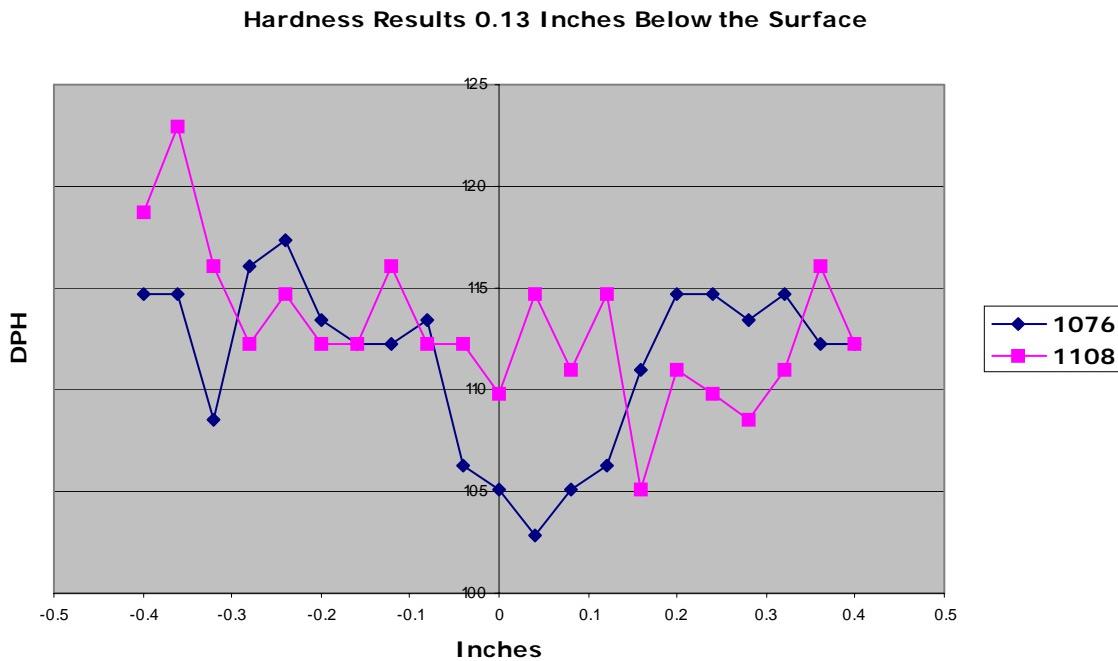
The similarity between the two samples is again on the advancing side of the stir nugget. Sample 1108 maintains consistent values into the stir zone whereas sample 1076 drops in DPH values within the stir zone. The comparison is graphed in Figure 26.

**Figure 26. Comparison between samples 1076 and 1108 0.130 inches below the surface (2099 Al-Li FSW)**

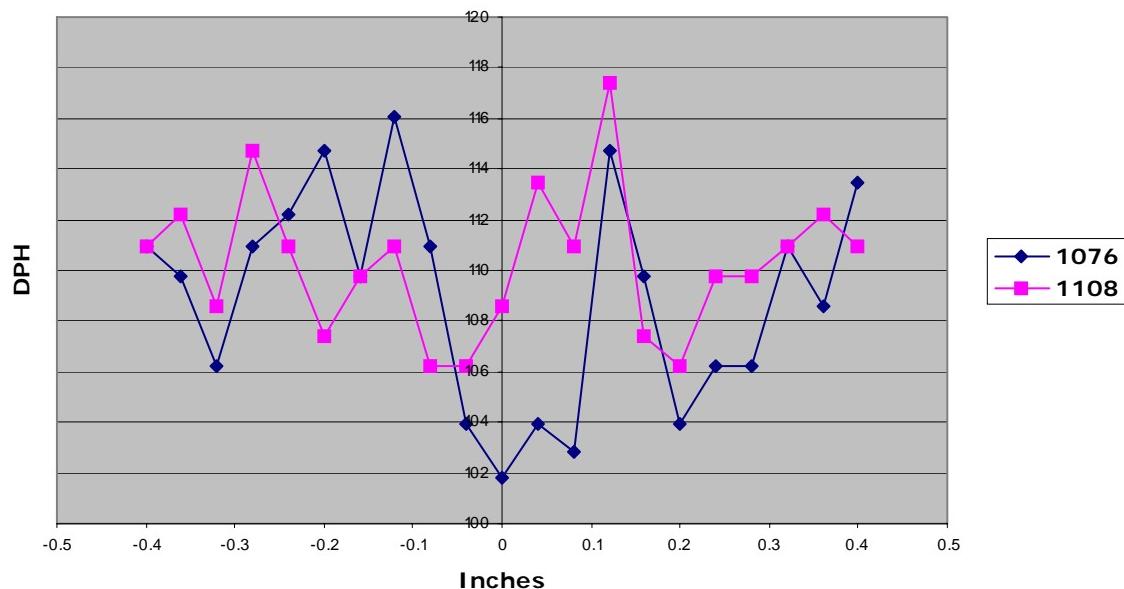
The last pass shown in Figure 27 has an increase in similarities compared to the first two depth comparisons. Even though the DPH values for sample 1076 dipped as much as 9 DPH below sample 1108 within the stir zone, the advancing and retreating sides are very similar. The dip in DPH values in the stir zone for both this pass and the pass at 0.13 inches could be due to the presence of the “Lazy S.”

**Figure 27. Comparison between samples 1076 and 1108 0.20 inches below the surface (2099 Al-Li FSW)**

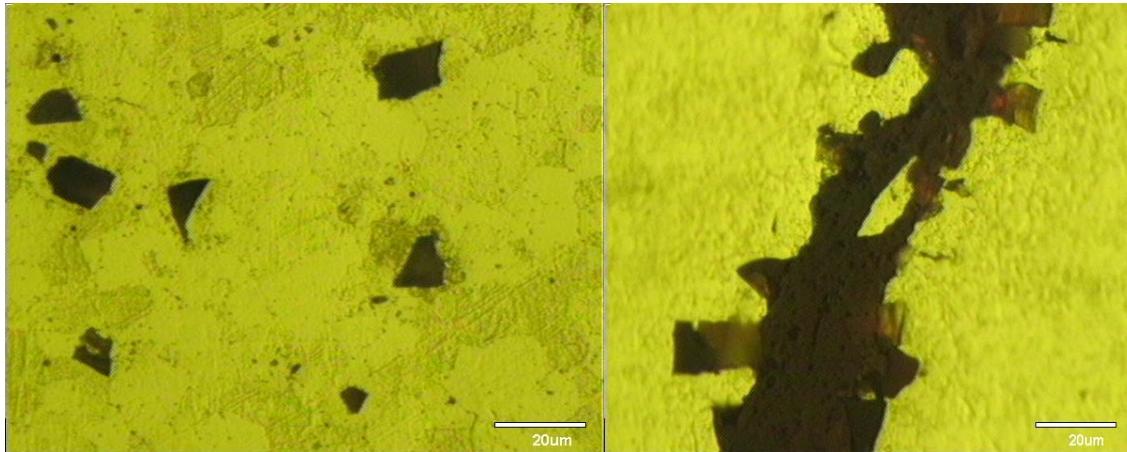
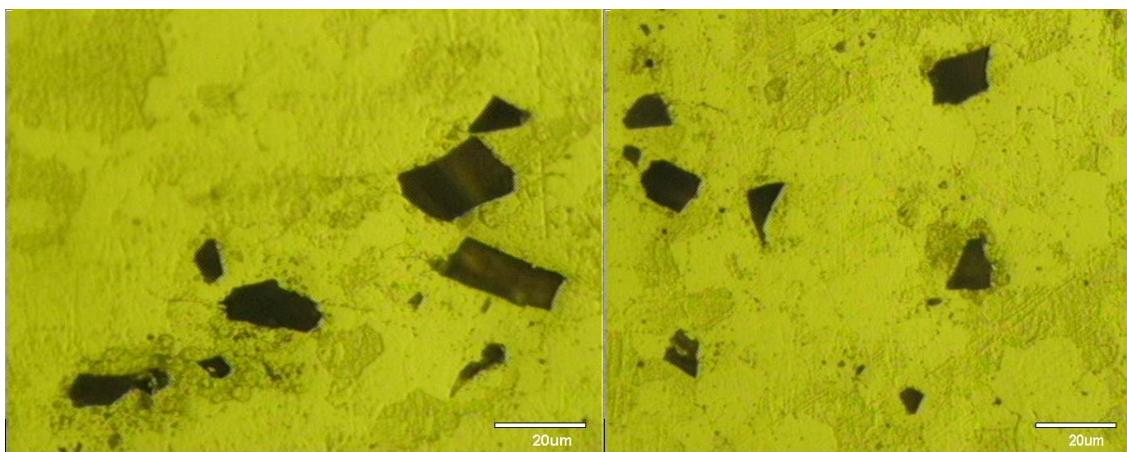
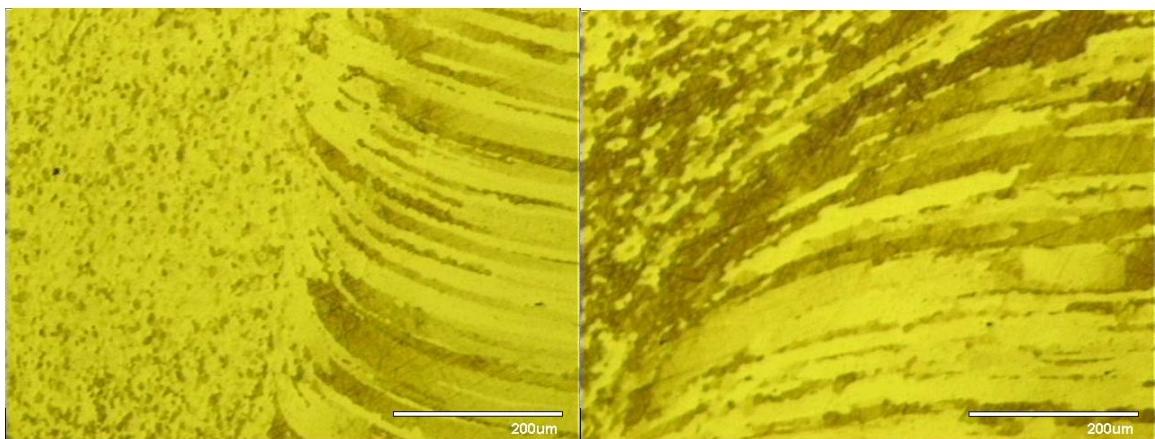
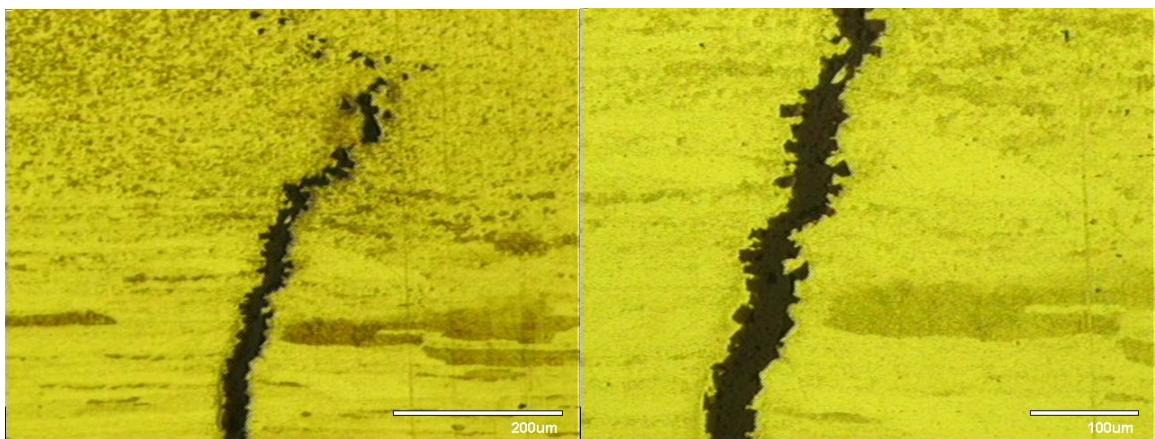
Sample 1076 - Anodized to Unanodized, centerline weld, standard tool
